EDWARD M. PRIBONIC, P.E., Inc.
4825 Hazelnut Avenue
Seal Beach, CA 90740
ENGINEERING DESIGN and CONSULTING
Ph. (562) 493-2946 Fax (562) 493-0127
E mail: emp@pribonic.com

City of Long Beach
 Department of Economic & Property Development
 333 W. Ocean Blvd., 3rd Floor
 Long Beach, CA 90802

February 3, 2018

The following is Inspection Report #372. The inspection of the property was conducted January 31, 2018.

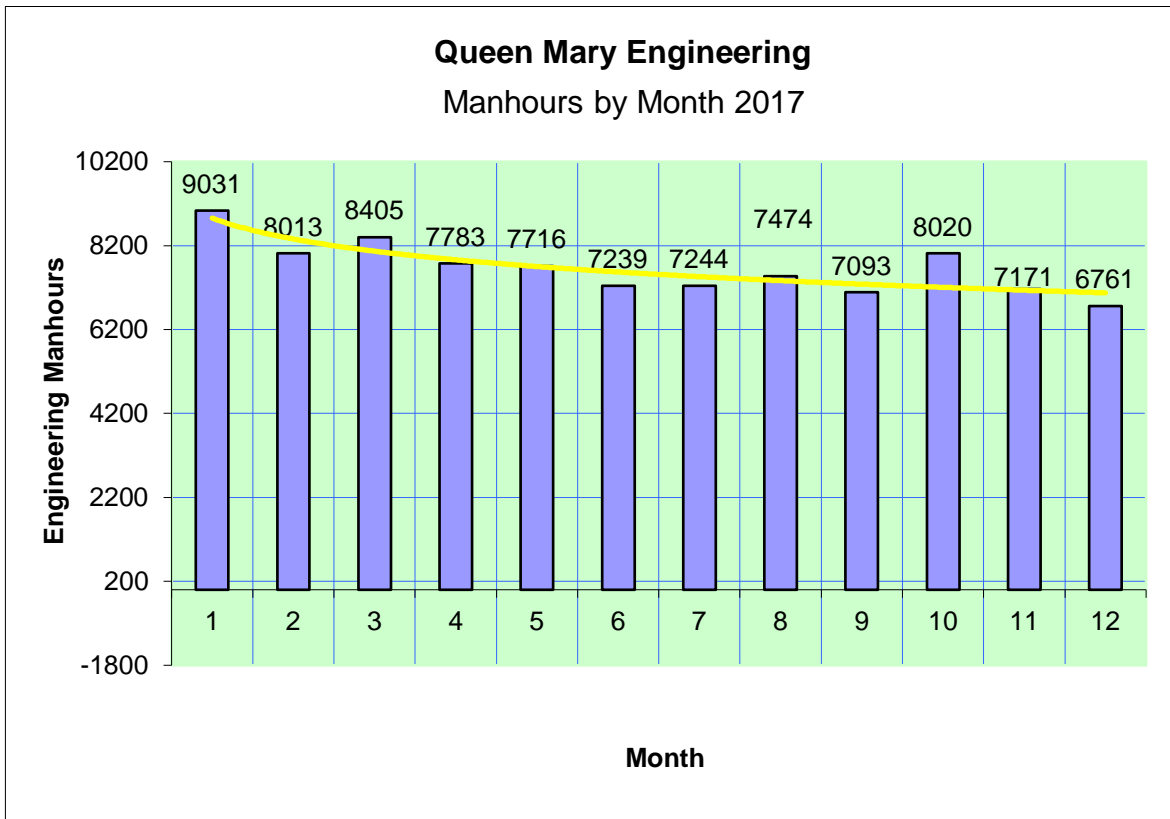
As noted in the Engineering Manpower chart above, there was a steady decline in manhours dedicated to the BMP throughout 2017. The hours expended, (as depicted in the chart), include special event manhours for things such as Chill, Dark Harbor and other activities throughout the year, which did not go to supporting maintenance.
