City of Long Beach
Department of Economic & Property Development
333 W. Ocean Blvd., 3rd Floor
Long Beach, CA 90802

The following is Inspection Report #391. The inspection of the property was conducted August 29, 2019.

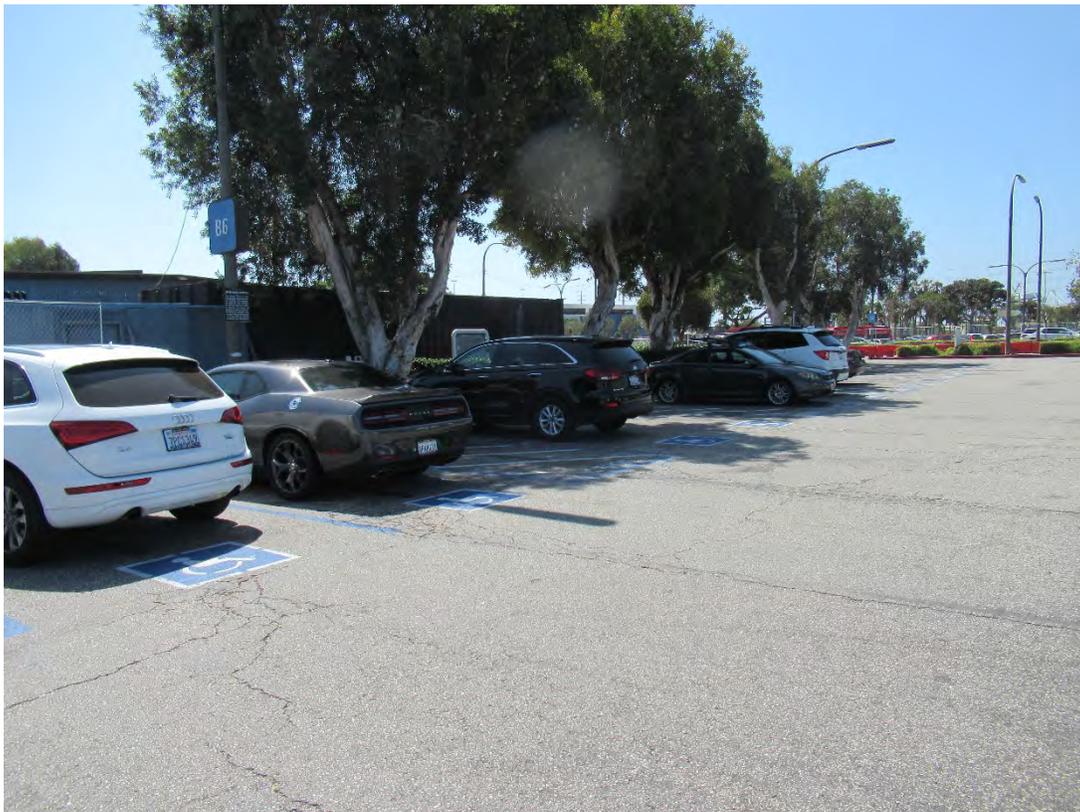
- A. Entrance
No activity this period.
- B. Pavement
The deficiencies reported last month, related to the relocation of the Handicapped parking area, remain uncorrected. Parking places are not properly marked and signed. See Photo No. 1. The crosswalk is not properly painted and there is no curb cut for wheelchair access. See Photo No. 2. This is a legal issue that cannot be ignored.
ACTION ITEM: Staff to present an action plan for discussion at the next inspection.

Photo No. 1. The relocated is still not properly marked and signed.

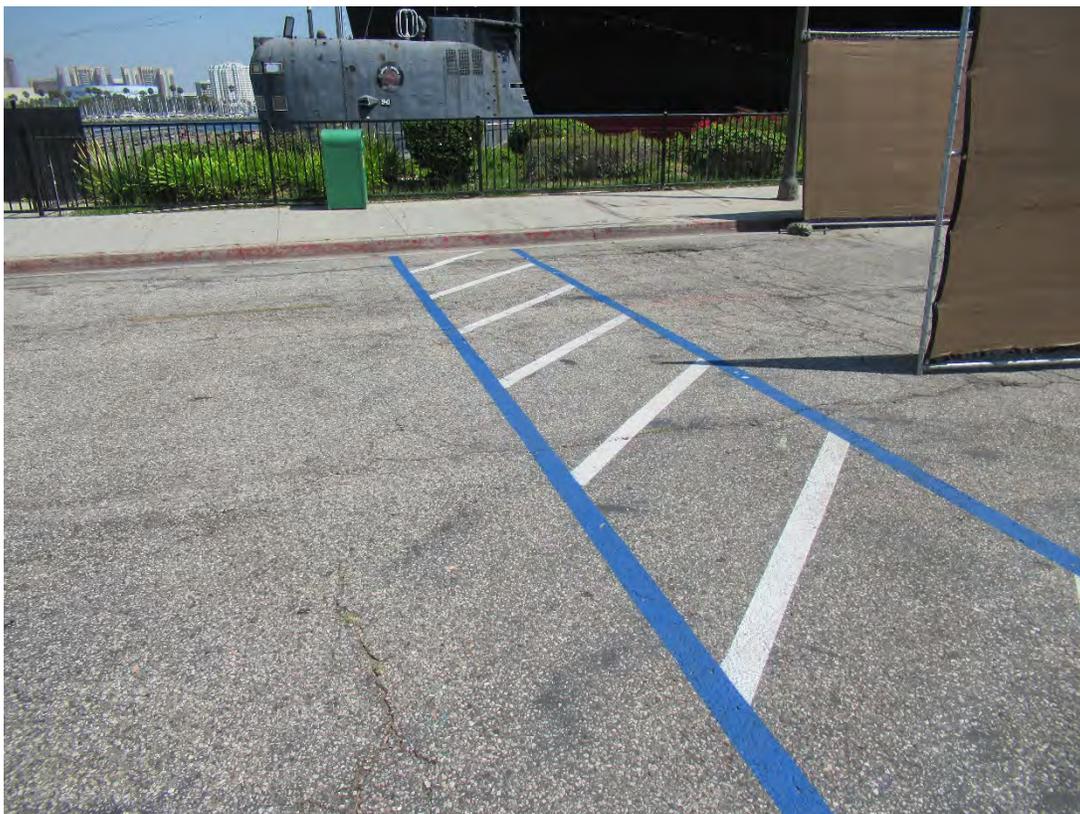
Photo No. 2. The crosswalk terminates in a curb without a cut for wheelchair access. This condition has not been corrected and was reported last month.

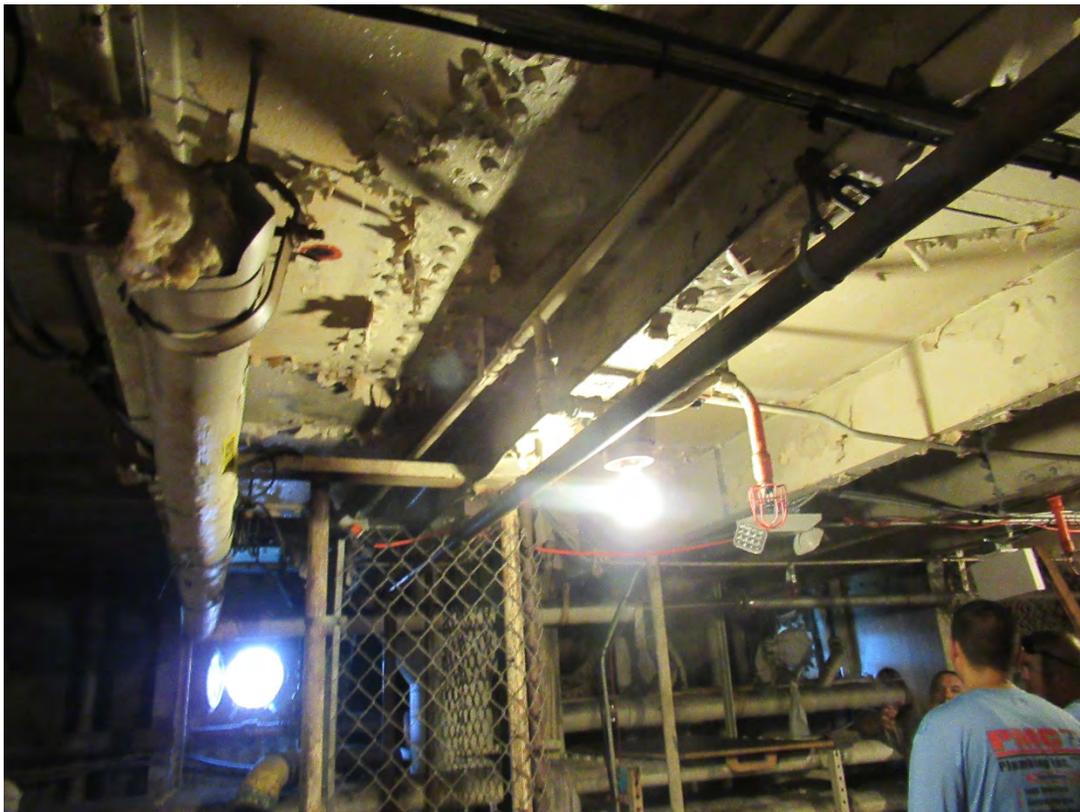
There has never been testing of the installed old materials, or the new materials and, to my knowledge, no inspections or reports from LBFD or any other safety related agency or individual. See Photos Nos. 3,4 and 5. These serious concerns have been unaddressed for nearly two years. The issue is public safety and without any response from the City or the lessee, I believe have a professional and contractual obligation to elevate these concerns until they are properly addressed and/or mitigated.

Photo No. 3. Unabated hazardous materials still remain in many active areas.

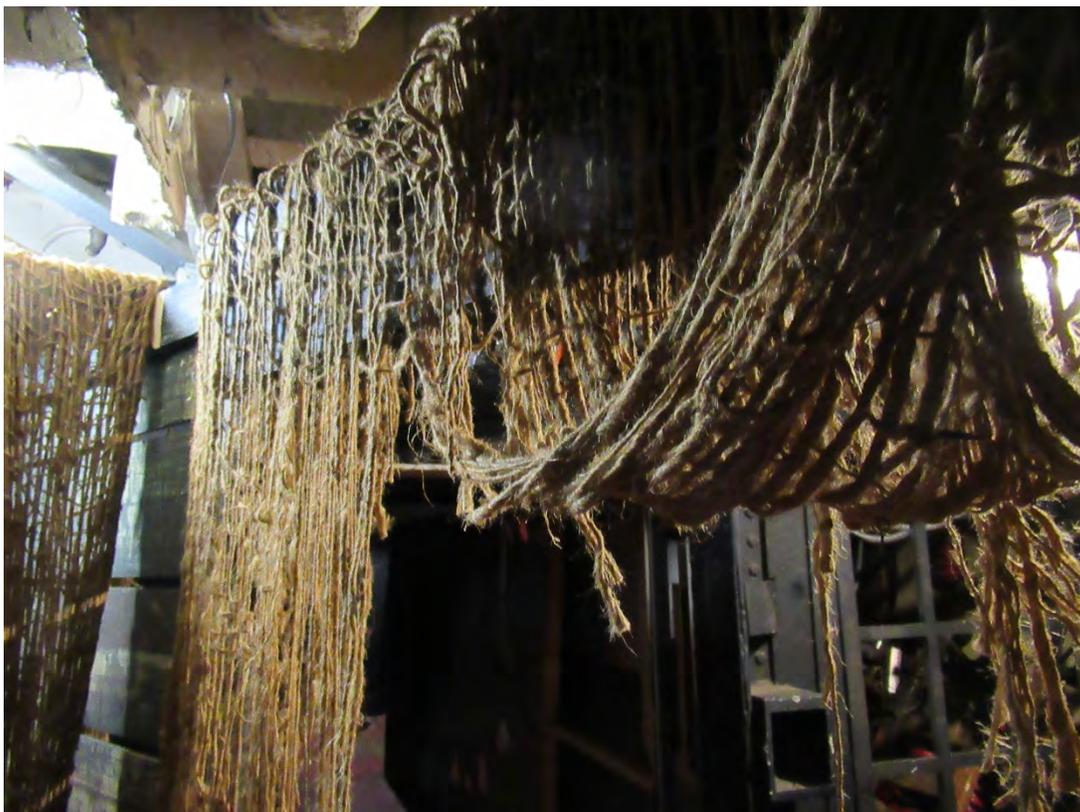
Photo No. 4. The same flammable materials warned about last year are being installed again.

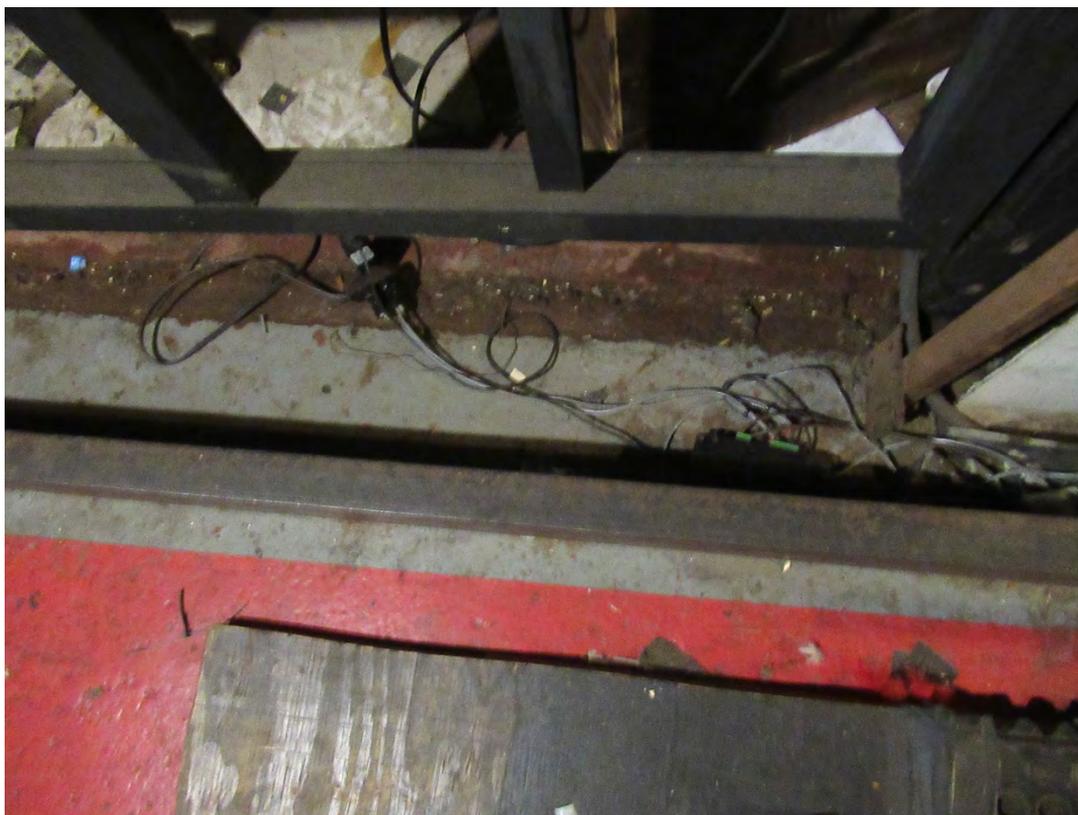
Photo No. 5. Improper wiring in the maze remains in spite of over a year of objections.

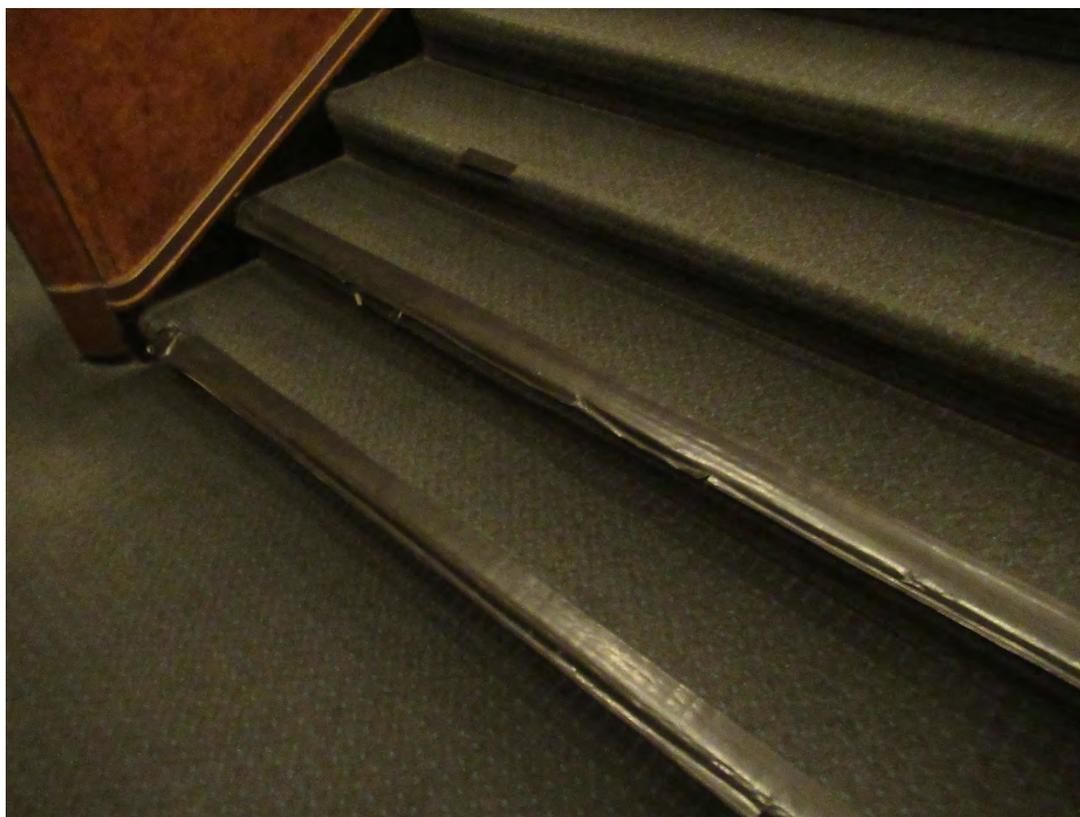
Carpeting damage and the use of duct tape for repairs still remain as reported last month. See Photos Nos. 6 and 7.

Photo No. 6. Deteriorating duct tape is presenting its own hazard as an inappropriate repair.

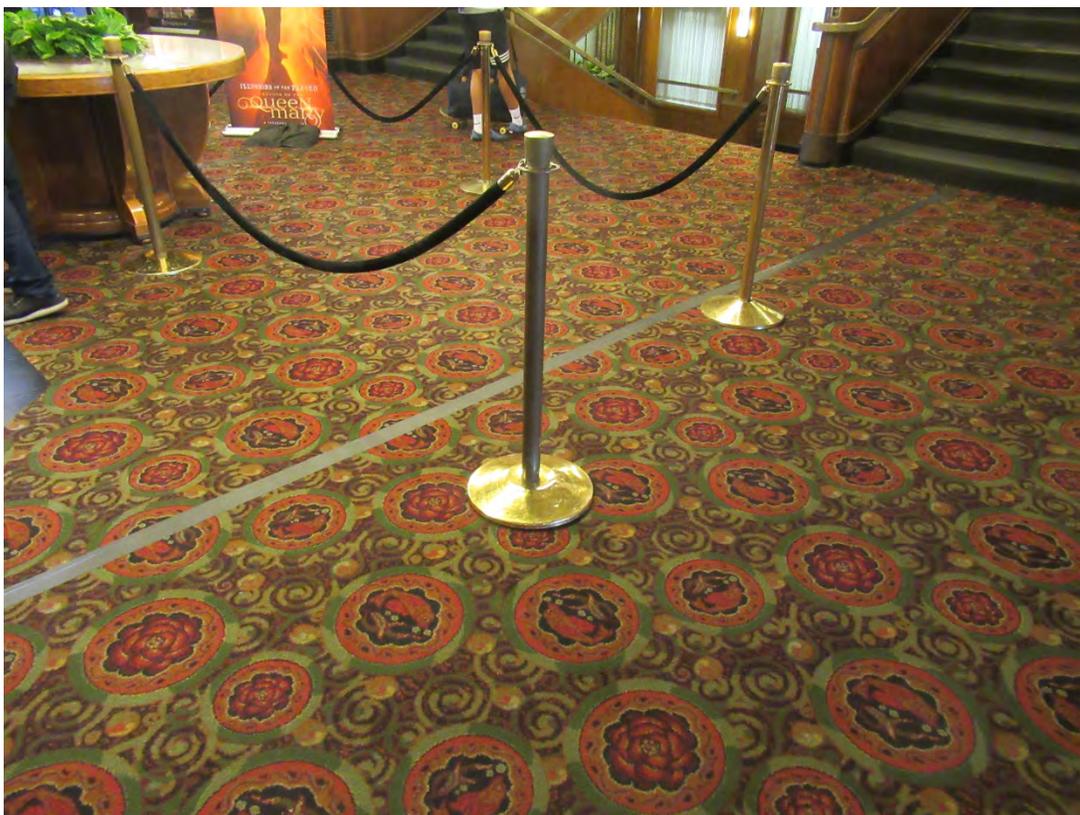
Photo No. 7. The same poor temporary repairs of carpeting remain unchanged.

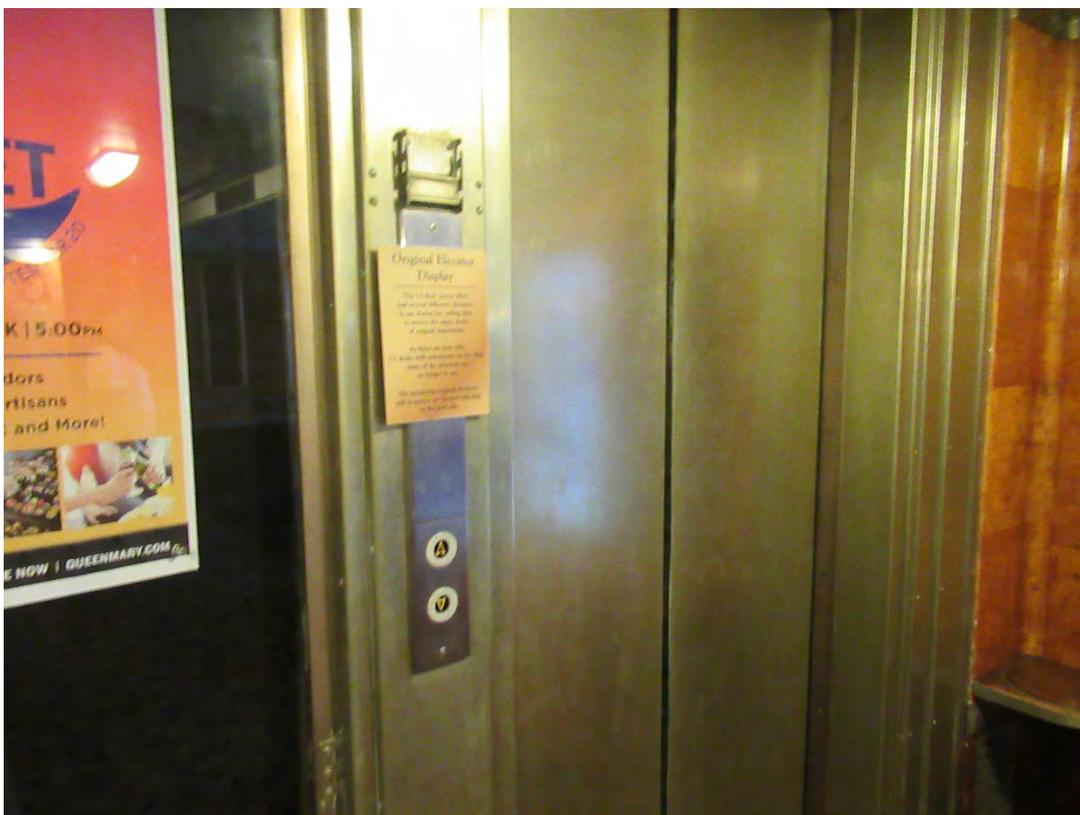
Several other conditions of damage and deterioration reported in previous months remain unaddressed, such as damaged elevator panel in the hotel lobby, damaged flooring in the lobby, and flooring in Main Hall. See Photos Nos. 8, 9, 10, 11, 12, and 13.

Photo No. 8. The elevator display in the Hotel Lobby remains in poor condition,

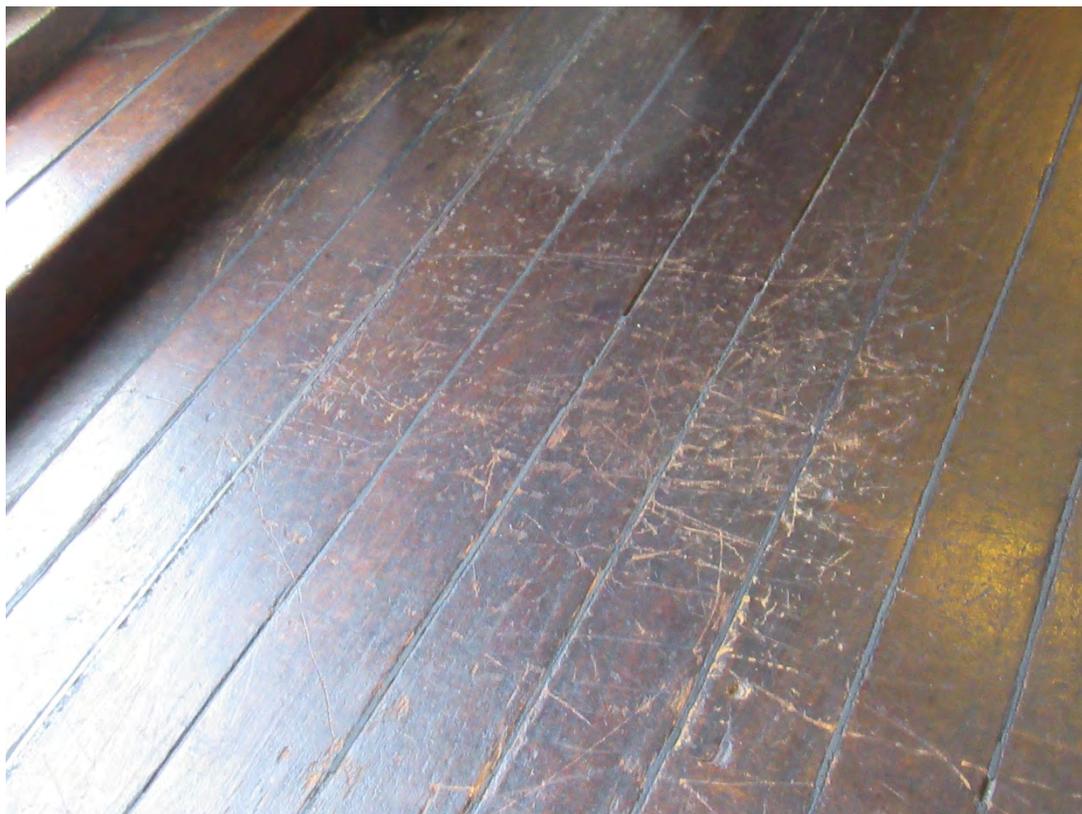
Photo No. 9. The damaged flooring in the Lobby also remains as previously shown.

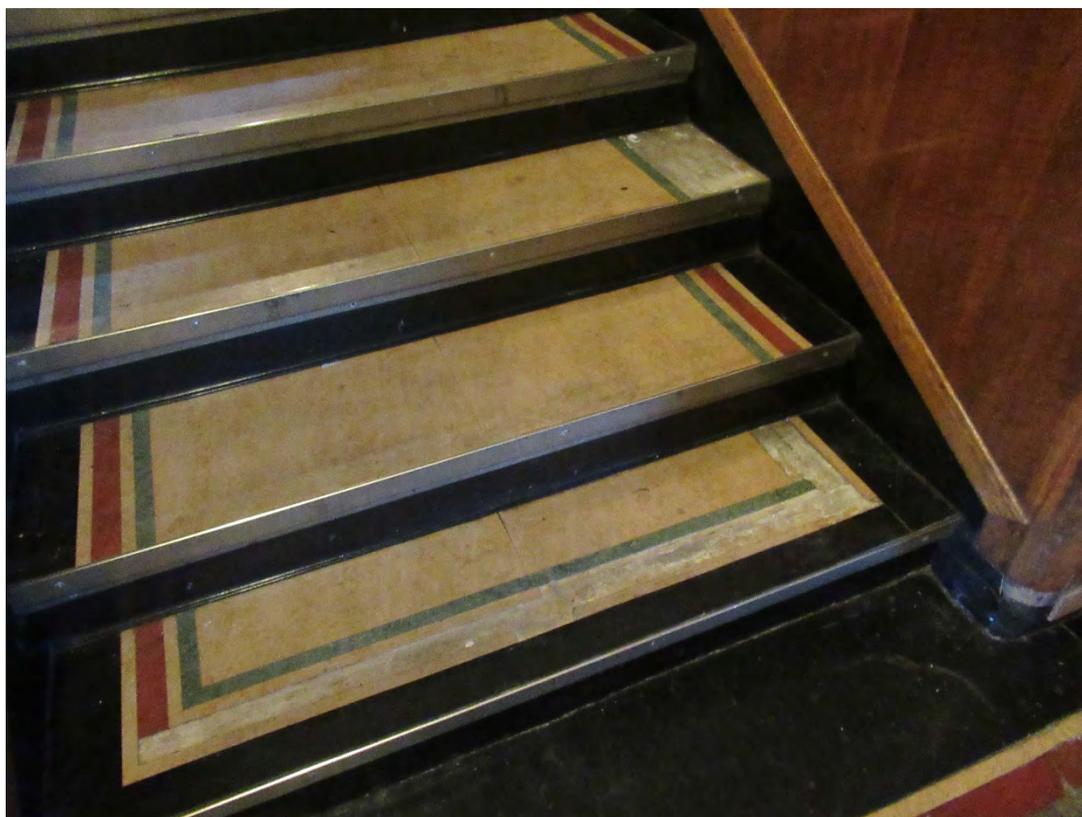
Photo No. 10. The Main Hall flooring is getting worse by the month and no repairs are being made.

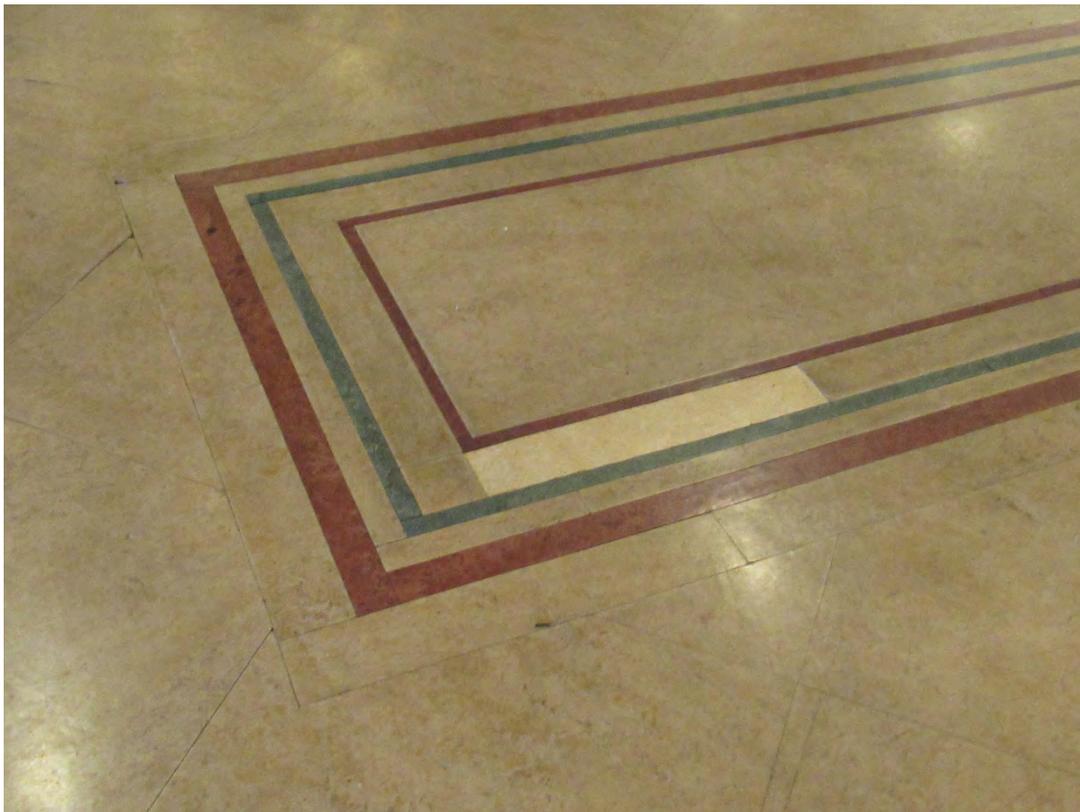
Photo No. 11. There is no program for flooring repairs.

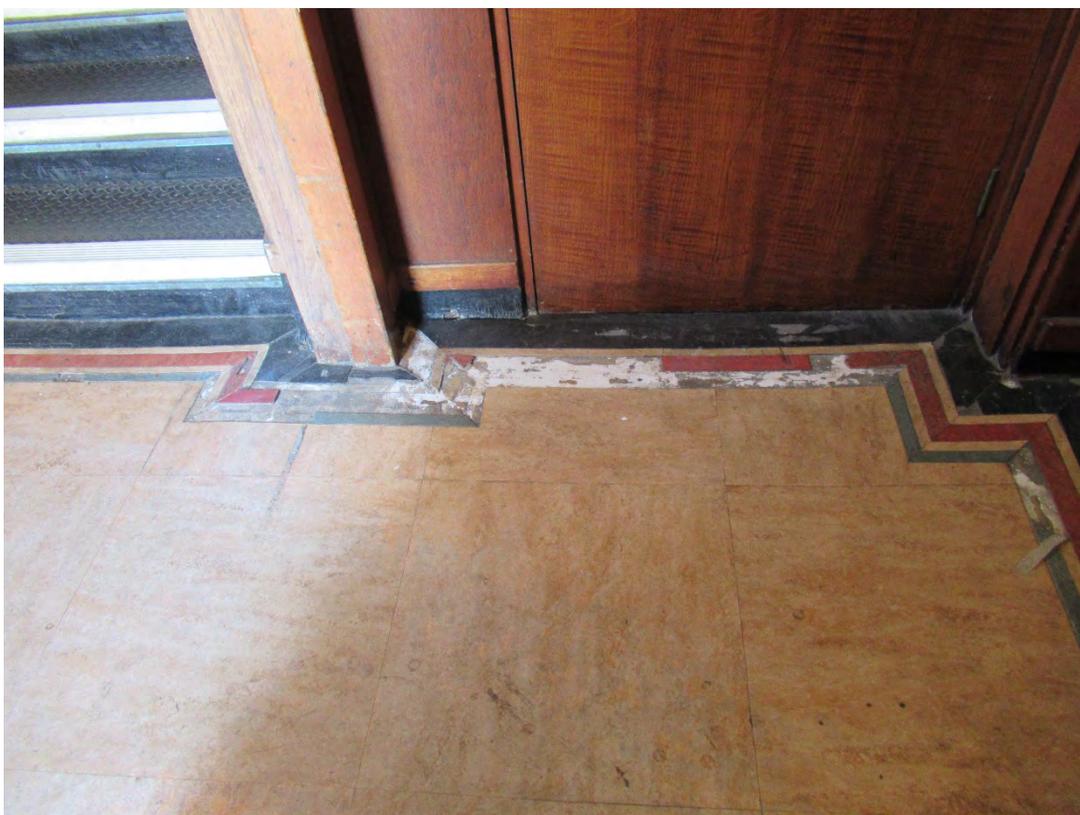
Photo No. 12. Pieces of flooring are falling coming loose, yet no repairs are made.

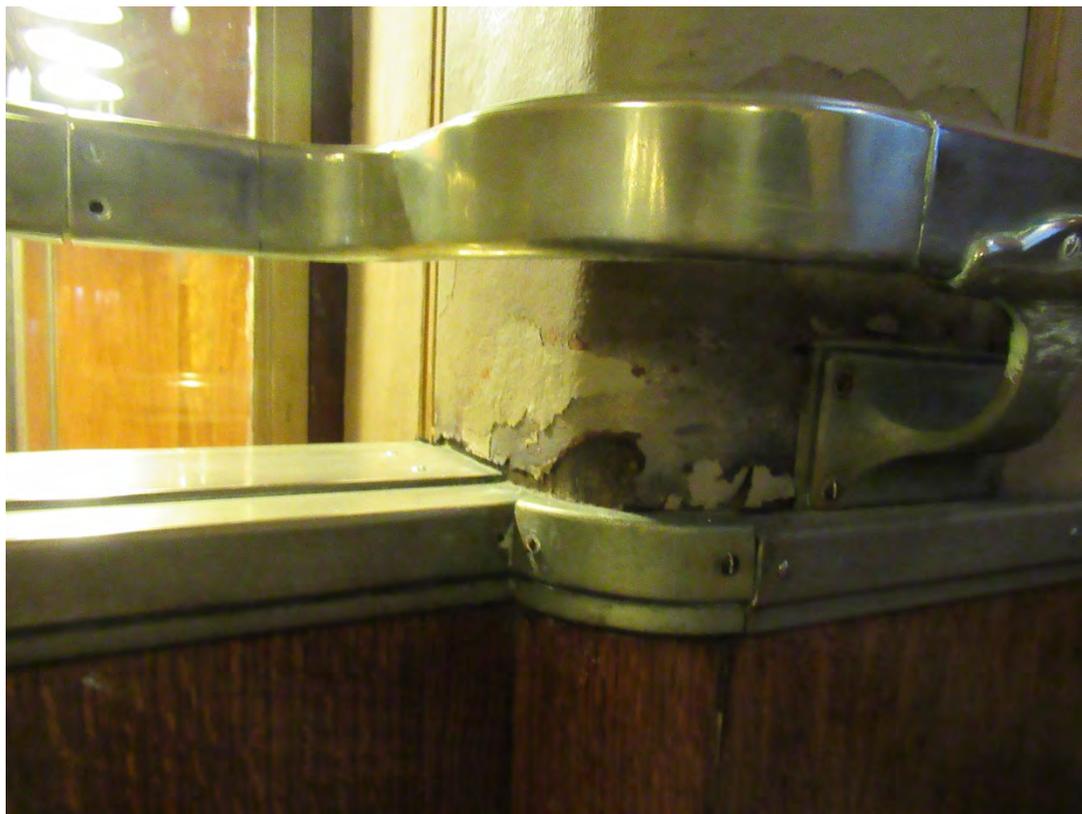
Photo No. 13. Wall covering in the Main Hall is also in very bad condition.

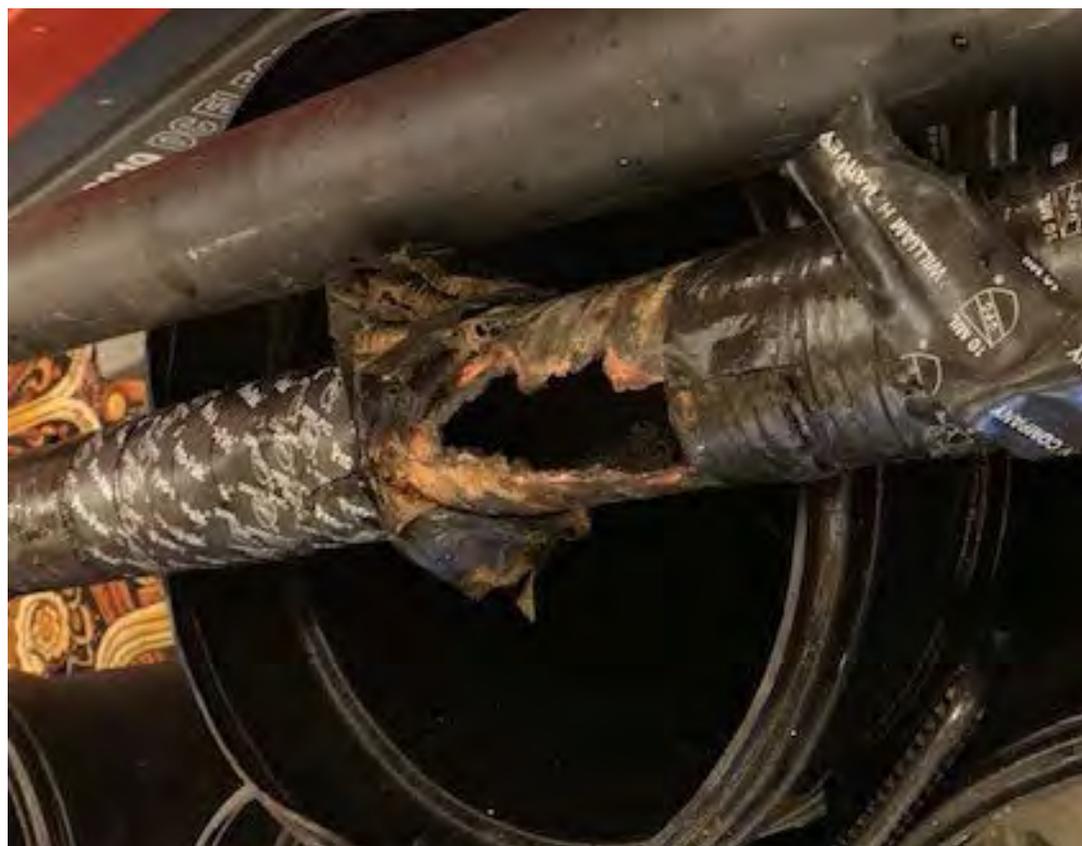
There are ceiling areas on R deck that have been damaged by leakage, presumably a sewage leak, that appear now to have developed Black mold. See Photo No. 14.

Photo No. 14. Temporary repairs to a sewage pipe were made with duct tape. It subsequently broke open and flooded the Grand Ballroom.

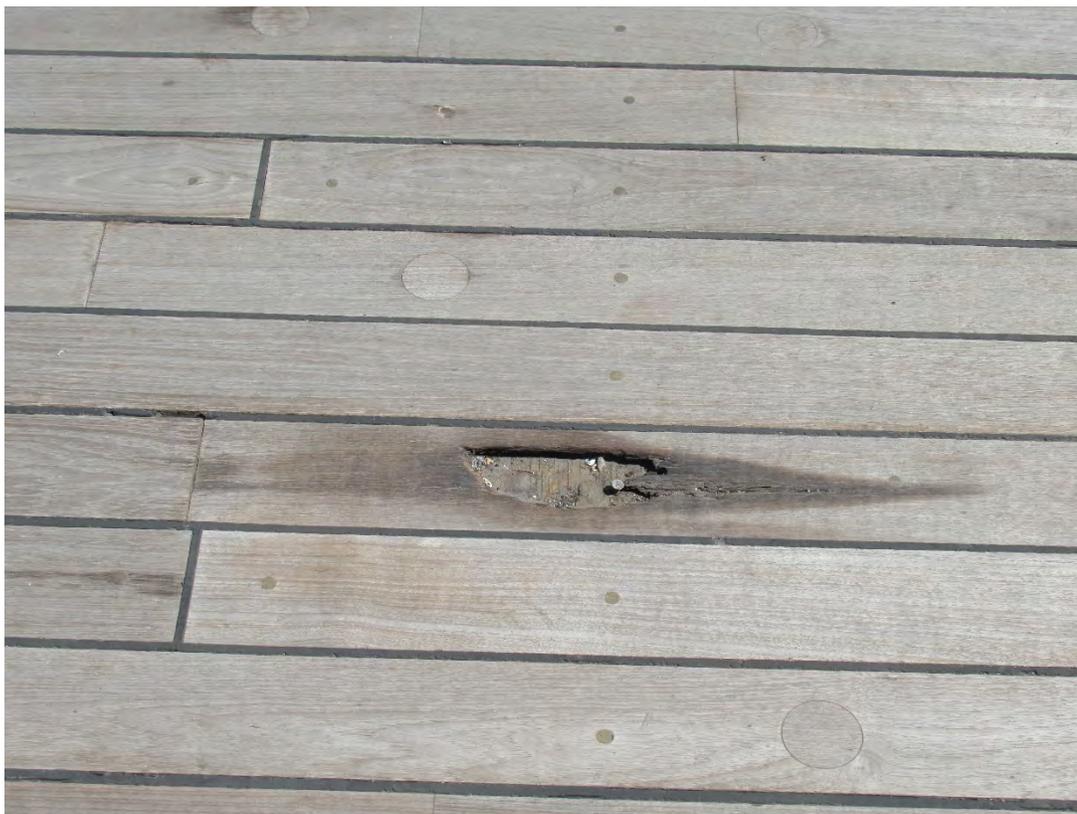
- A. Corrosion Control Systems**
Small damaged areas of Sun deck, which are trip hazards, and easily repaired, remain month after month. See Photo No. 15.

Photo No. 15. A large hole in Sun deck with an exposed screw head has been unrepaired for many months and presents a trip hazard.

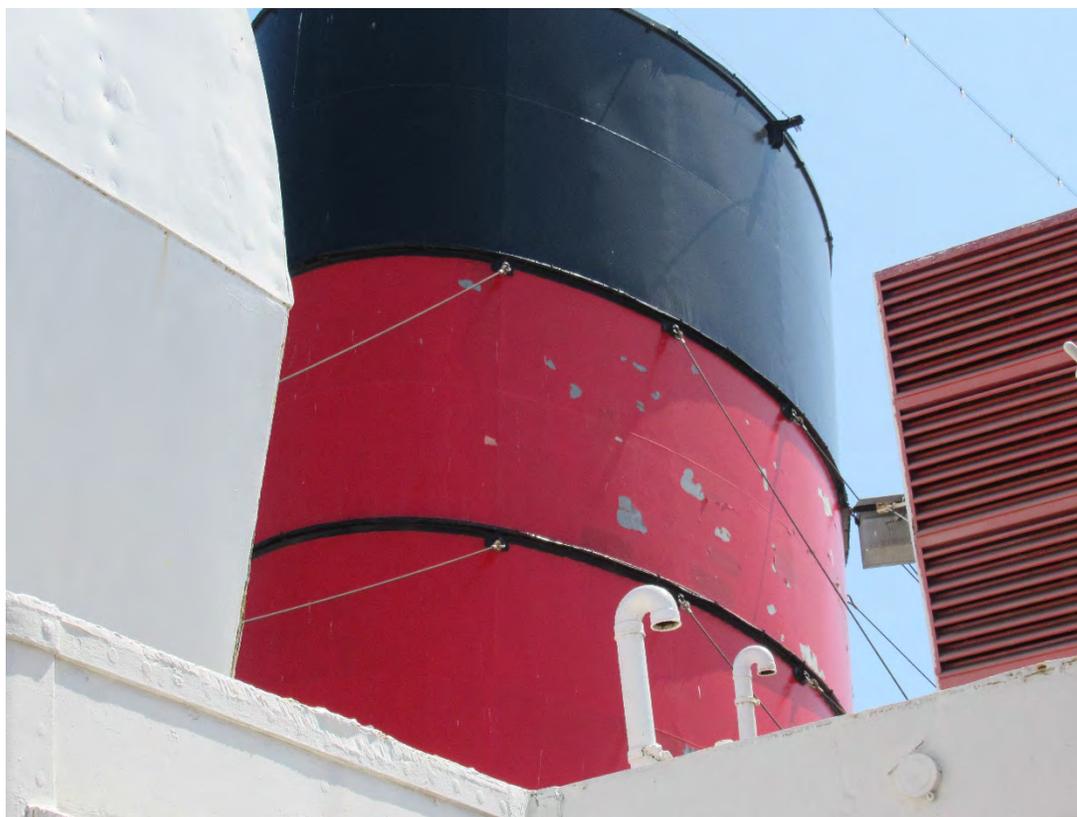
- B. Vessel Exterior**
Deteriorated paint has been reported many times previously have not been addressed and remain in poor condition. See Photos Nos. 16, 17 and 18.

Photo No. 16. Failed paint has been discussed for over a year and no answers have been forthcoming.

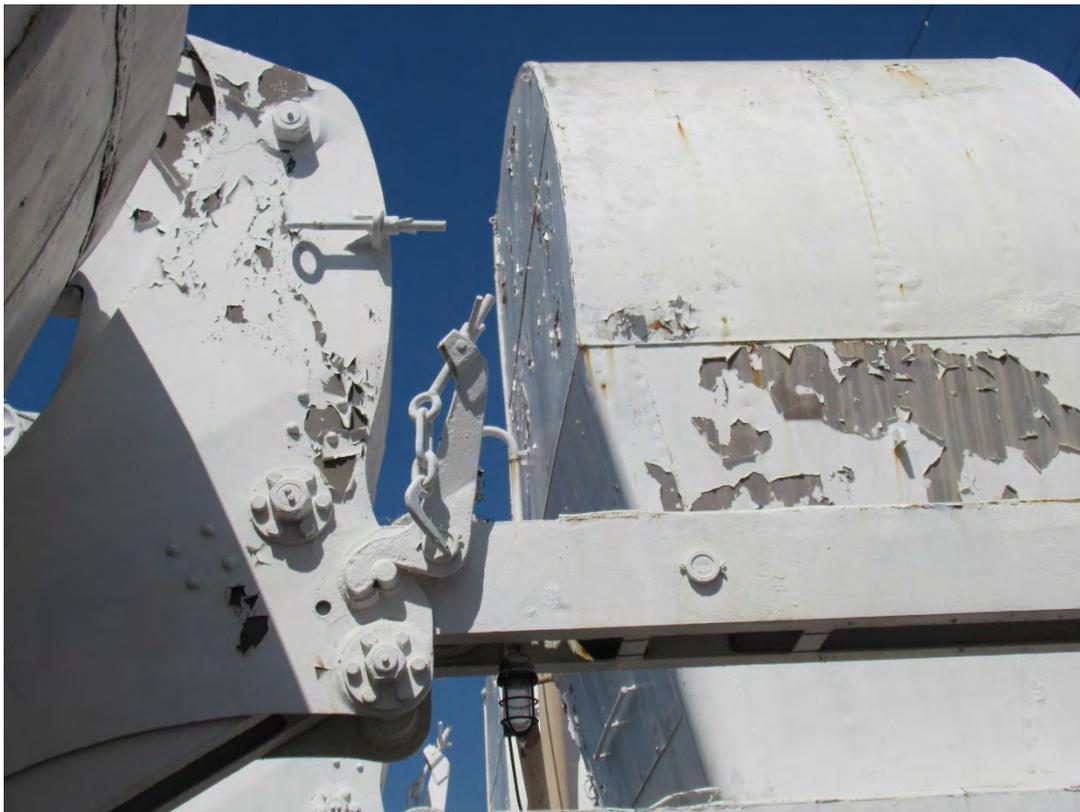
Photo No. 17. The terrible condition of paint throughout the ship are a clear indicator of understaffing and under funding of the BMP.

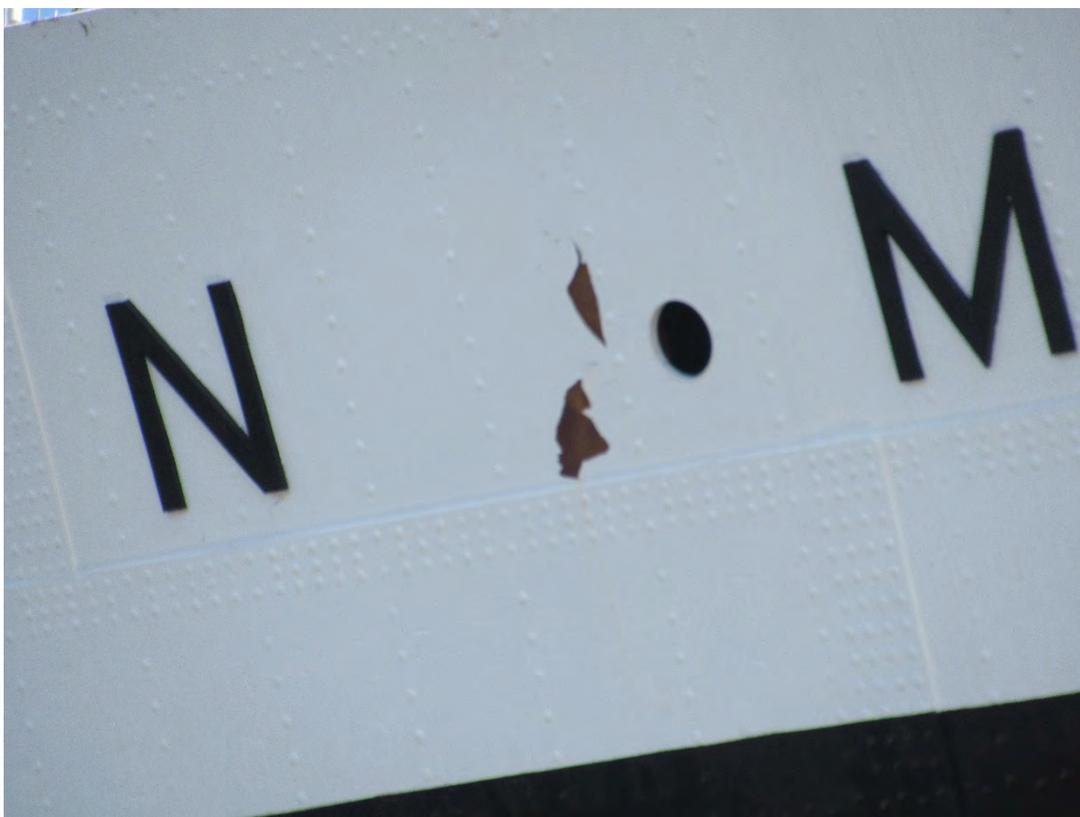
Photo No. 18. Paint failure of the recent work is occurring throughout all areas of the work.

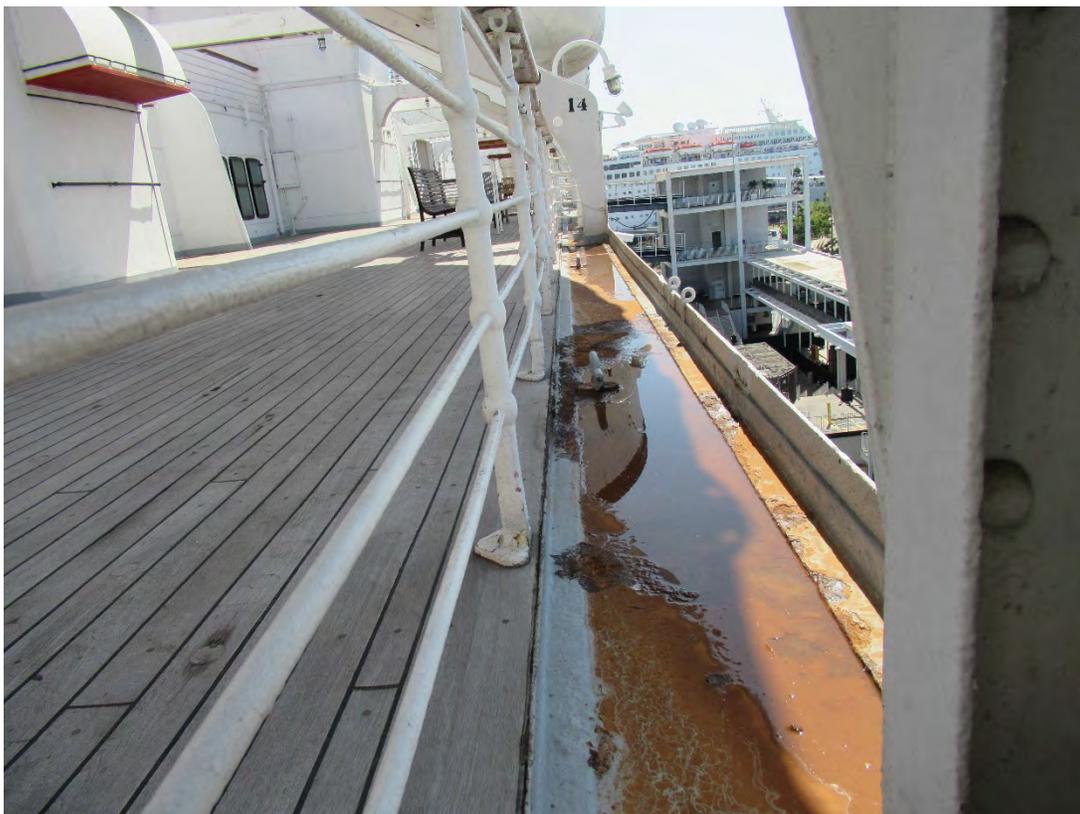
- C. Wetted Hull and Propeller Box**
No activity this period.
- D. Decks**
Sun deck scuppers remain in very poor condition as previously reported. See Photos Nos. 19 and 20. Handrails remain in poor condition.

Photo No. 19. The condition of the Sun deck scuppers is worse than it was last month.

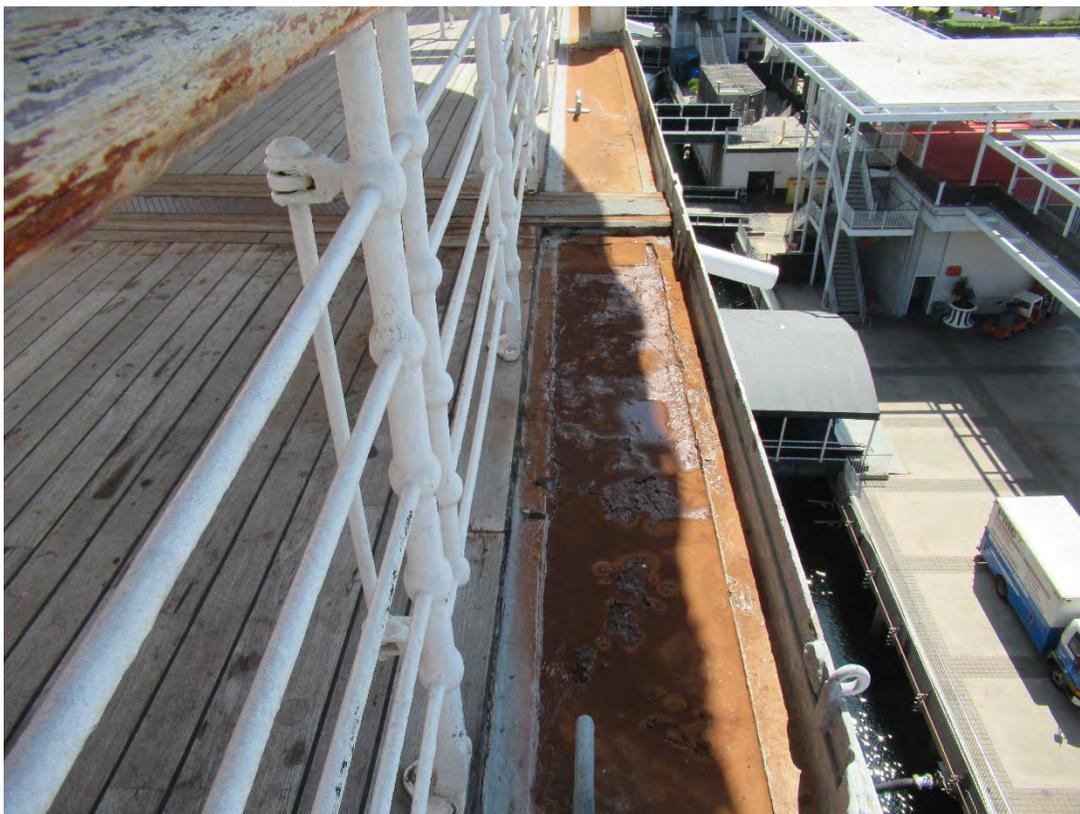
Photo No. 20. This is another example of conditions indicating under staffing and under funding of the BMP.

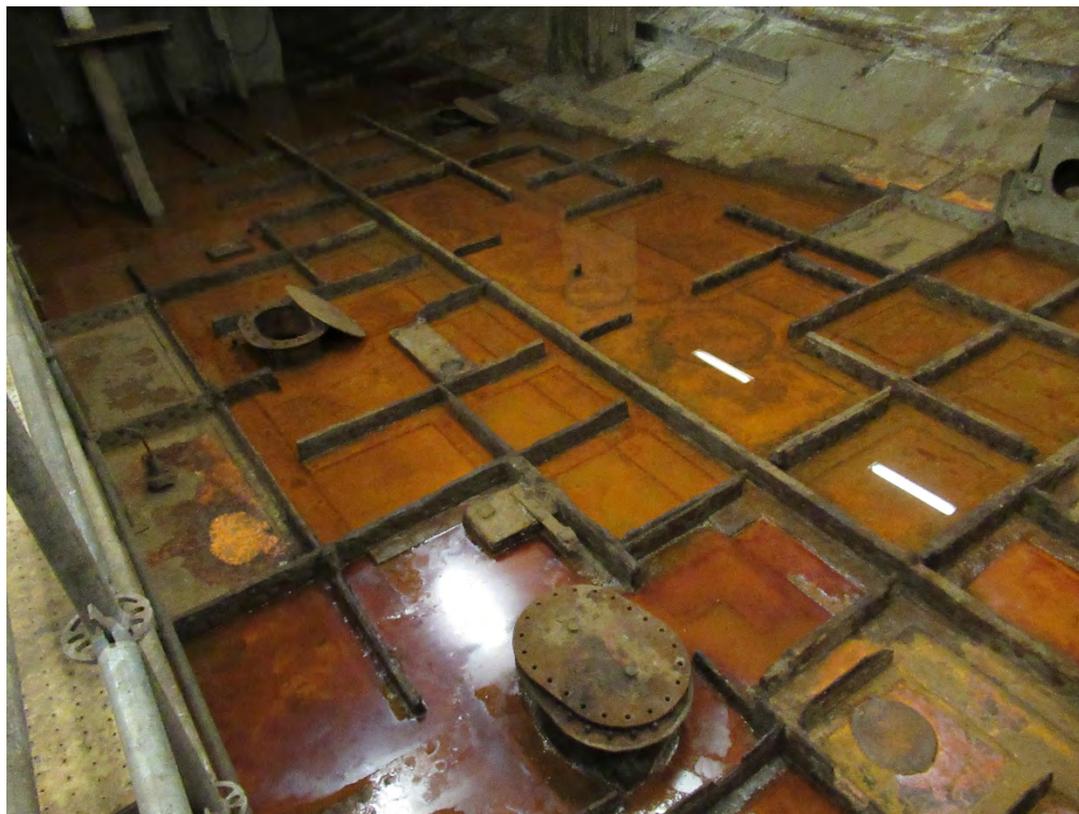
- E. Moorings**
No activity this period.
- F. Expansion Joints**
The expansion joints remain uncompleted as previously reported.
- G. Bilges**
The serious problem of standing water in the bilges is now a more serious problem. Hatch covers have been removed and it is obvious that the inter-hull space is flooded. See Photos Nos. 21, 22 and 23.
It is critical that the water source be determined to understand if the outer hull is leaking.

Photo No. 21. The standing water in the bilges, reported for almost a year, is getting worse, yet it is given no attention.

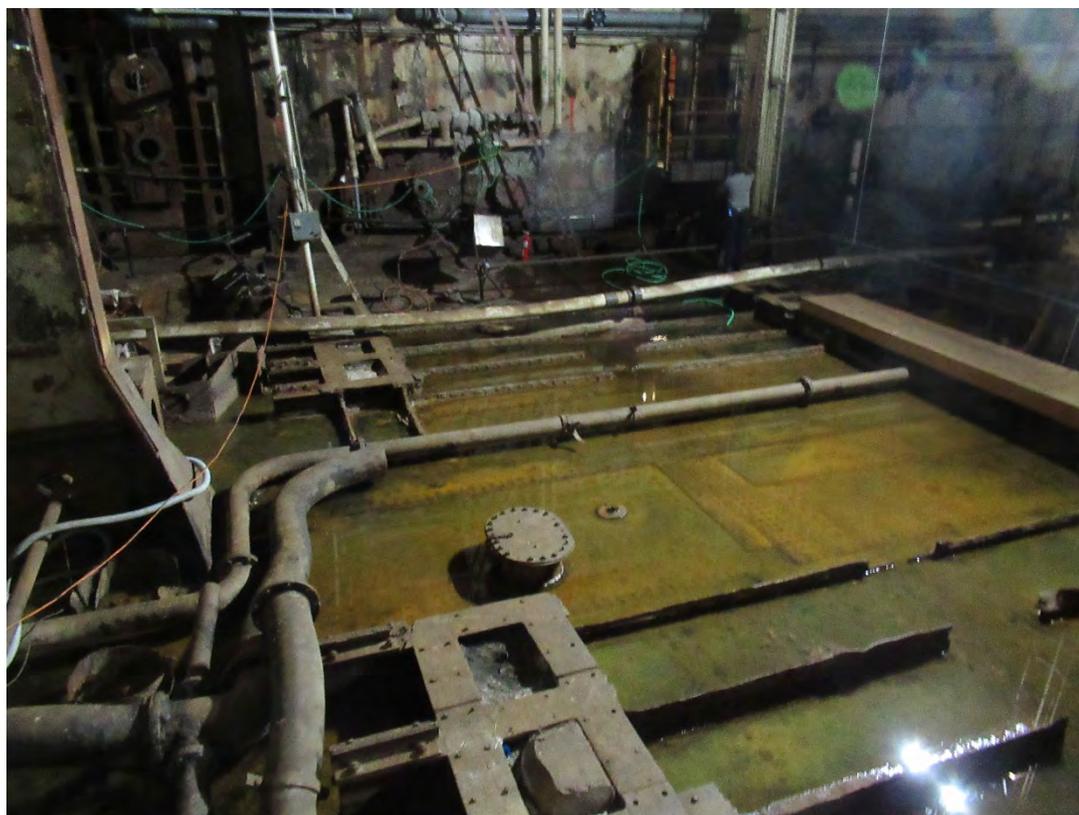
Photo No. 22. Areas of standing water are expanding.

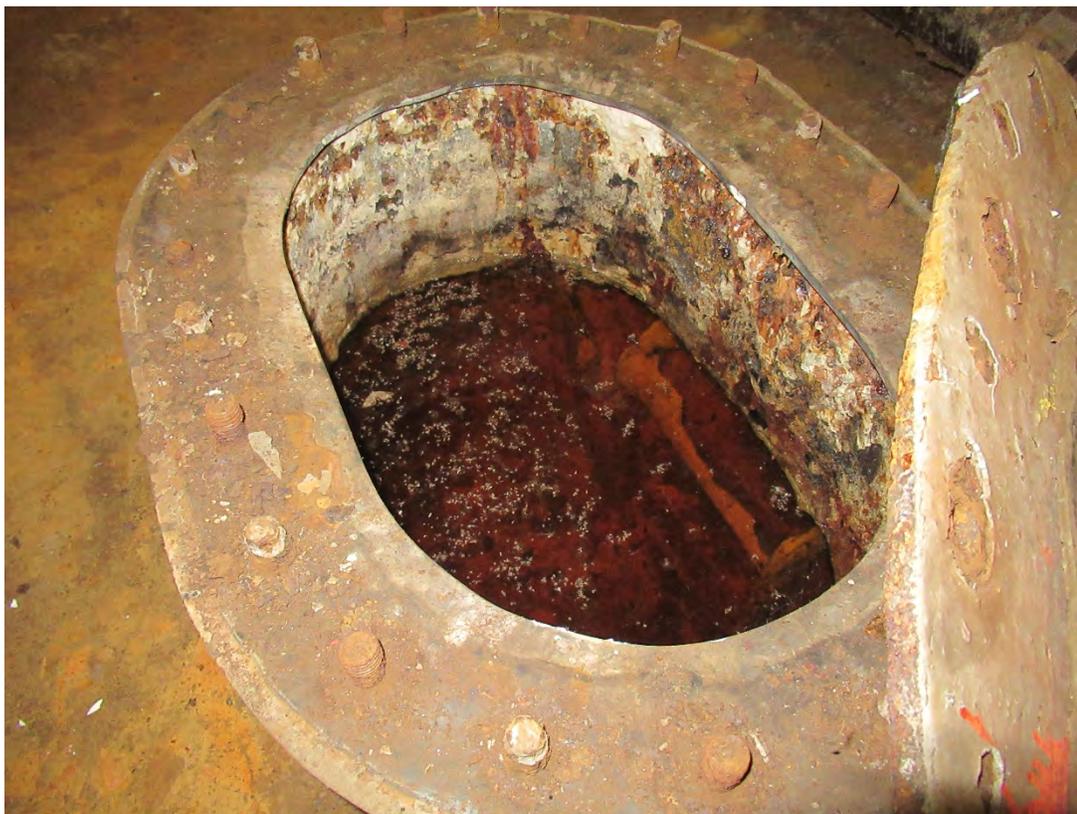
Photo No. 23. Hatches opened for unknown reasons, have shown that the inter-hull space is filled with water. If it is saltwater, that would indicate a breach of the outer hull.

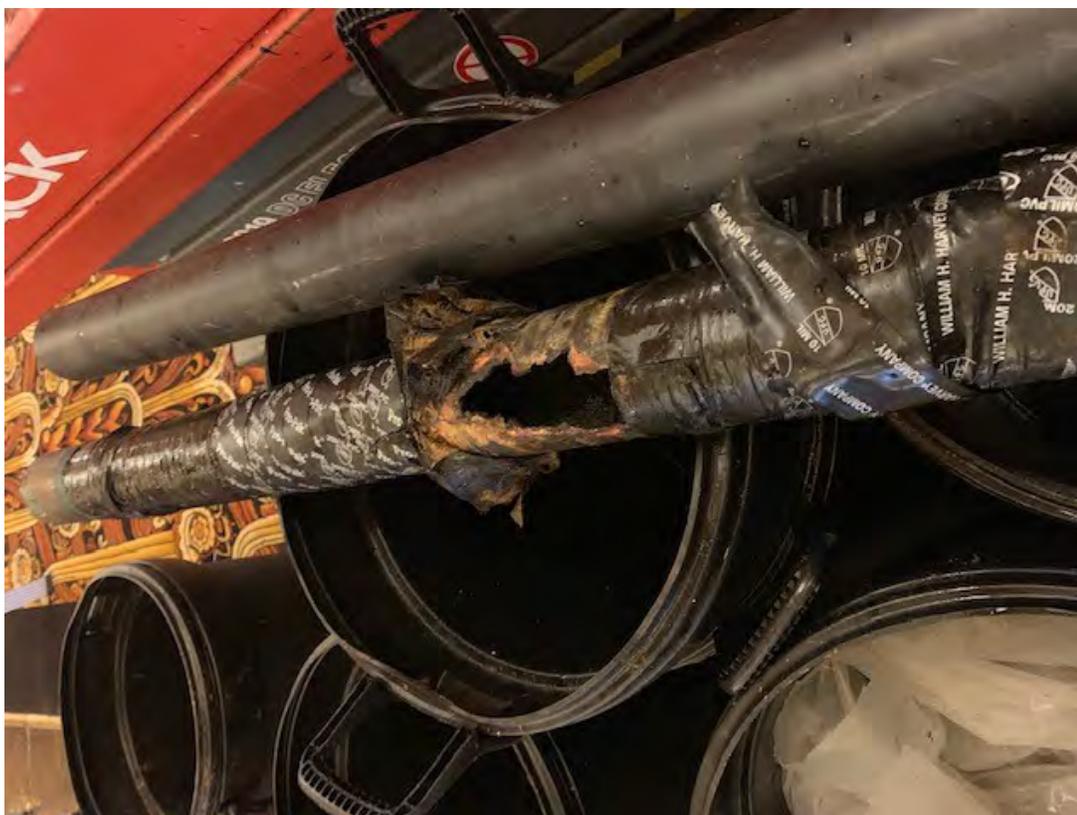
- A. Air Handling Equipment**
Major A/C units have no operating controls meaning that cooling zones cannot be properly regulated. The result is overly cold spaces and resulting excessive condensation on A/C piping. The condensation frequently causes water pooling and leaking onto ceilings or between walls causing additional damage.
- B. Piping and Plumbing**
No activity this period.
- C. Bilge Pumping System**
No activity this period.
- D. Sewage System**
A major sewage leak occurred in the Grand Ballroom. It was discovered that the pipe was fully corroded and held together with duct tape. See Photo No. 24.

Photo No. 24. A sewage line, repaired with duct tape, failed. The leak of raw sewage flooded the Grand Ballroom.
