City of Long Beach
Department of Economic & Property Development
333 W. Ocean Blvd., 3rd Floor
Long Beach, CA 90802

The following is Inspection Report #391. The inspection of the property was conducted August 29, 2019.

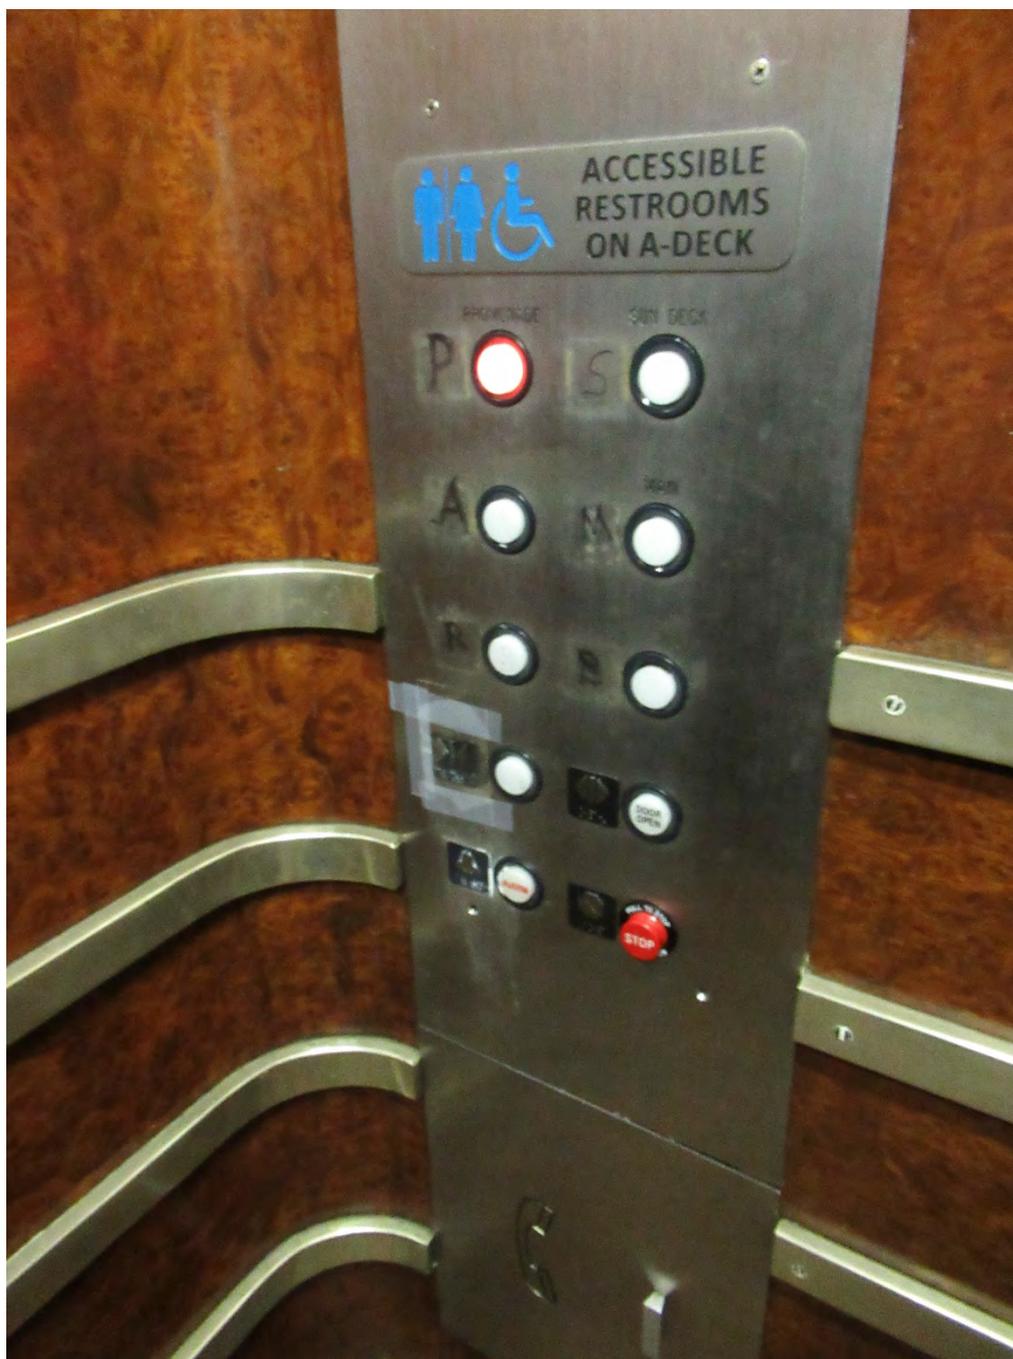
C. Elevators
The main elevator control panel is damaged and improperly marked. The use of marking pens and cellophane tape is an unacceptable repair. This may also be a violation of elevator safety codes. See Photo No. 25.

Photo No. 25. The starboard elevator cab control panel is a shameful display of the low level of maintenance being done aboard the ship.
