**EDWARD M. PRIBONIC, P.E., Inc.**  
4825 Hazelnut Avenue  
Seal Beach, CA 90740  
**ENGINEERING DESIGN and CONSULTING**  
Ph. (562) 493-2946 Fax (562) 493-0127  
E mail: emp@pribonic.com

The following is Inspection Report #374. The inspection of the property was conducted March 28, 2018.

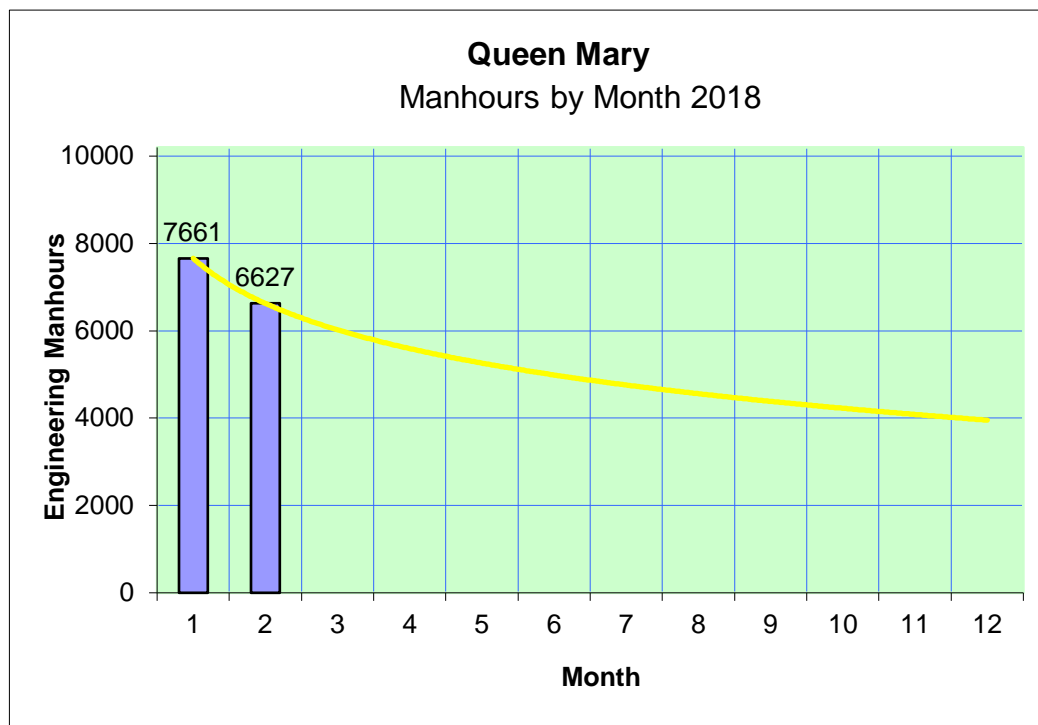
For the month of February manpower to implement the Base Maintenance Plan totaled 6,627 manhours. This represents a 13.5% decrease in manpower from January. It would be prudent to have the requested Base Maintenance Plan correlated to manpower needs for its implementation. The breakdown by department is below.

Carpentry	312	Manhours
Electrical	312	
Groundskeeper	800	
Maintenance	1,680	
Painting	136	
Plumbing	237	
Engineer	353	
Custodian	2,767
